MOHAWK RIVER BASIN  
TOWN OF GERMAN FLATTS  
HERKIMER COUNTY, NEW YORK

**ILION RESERVOIR  
NO. 2 DAM  
NY 00185**

PHASE I INSPECTION REPORT  
NATIONAL DAM INSPECTION PROGRAM

JULY 1981

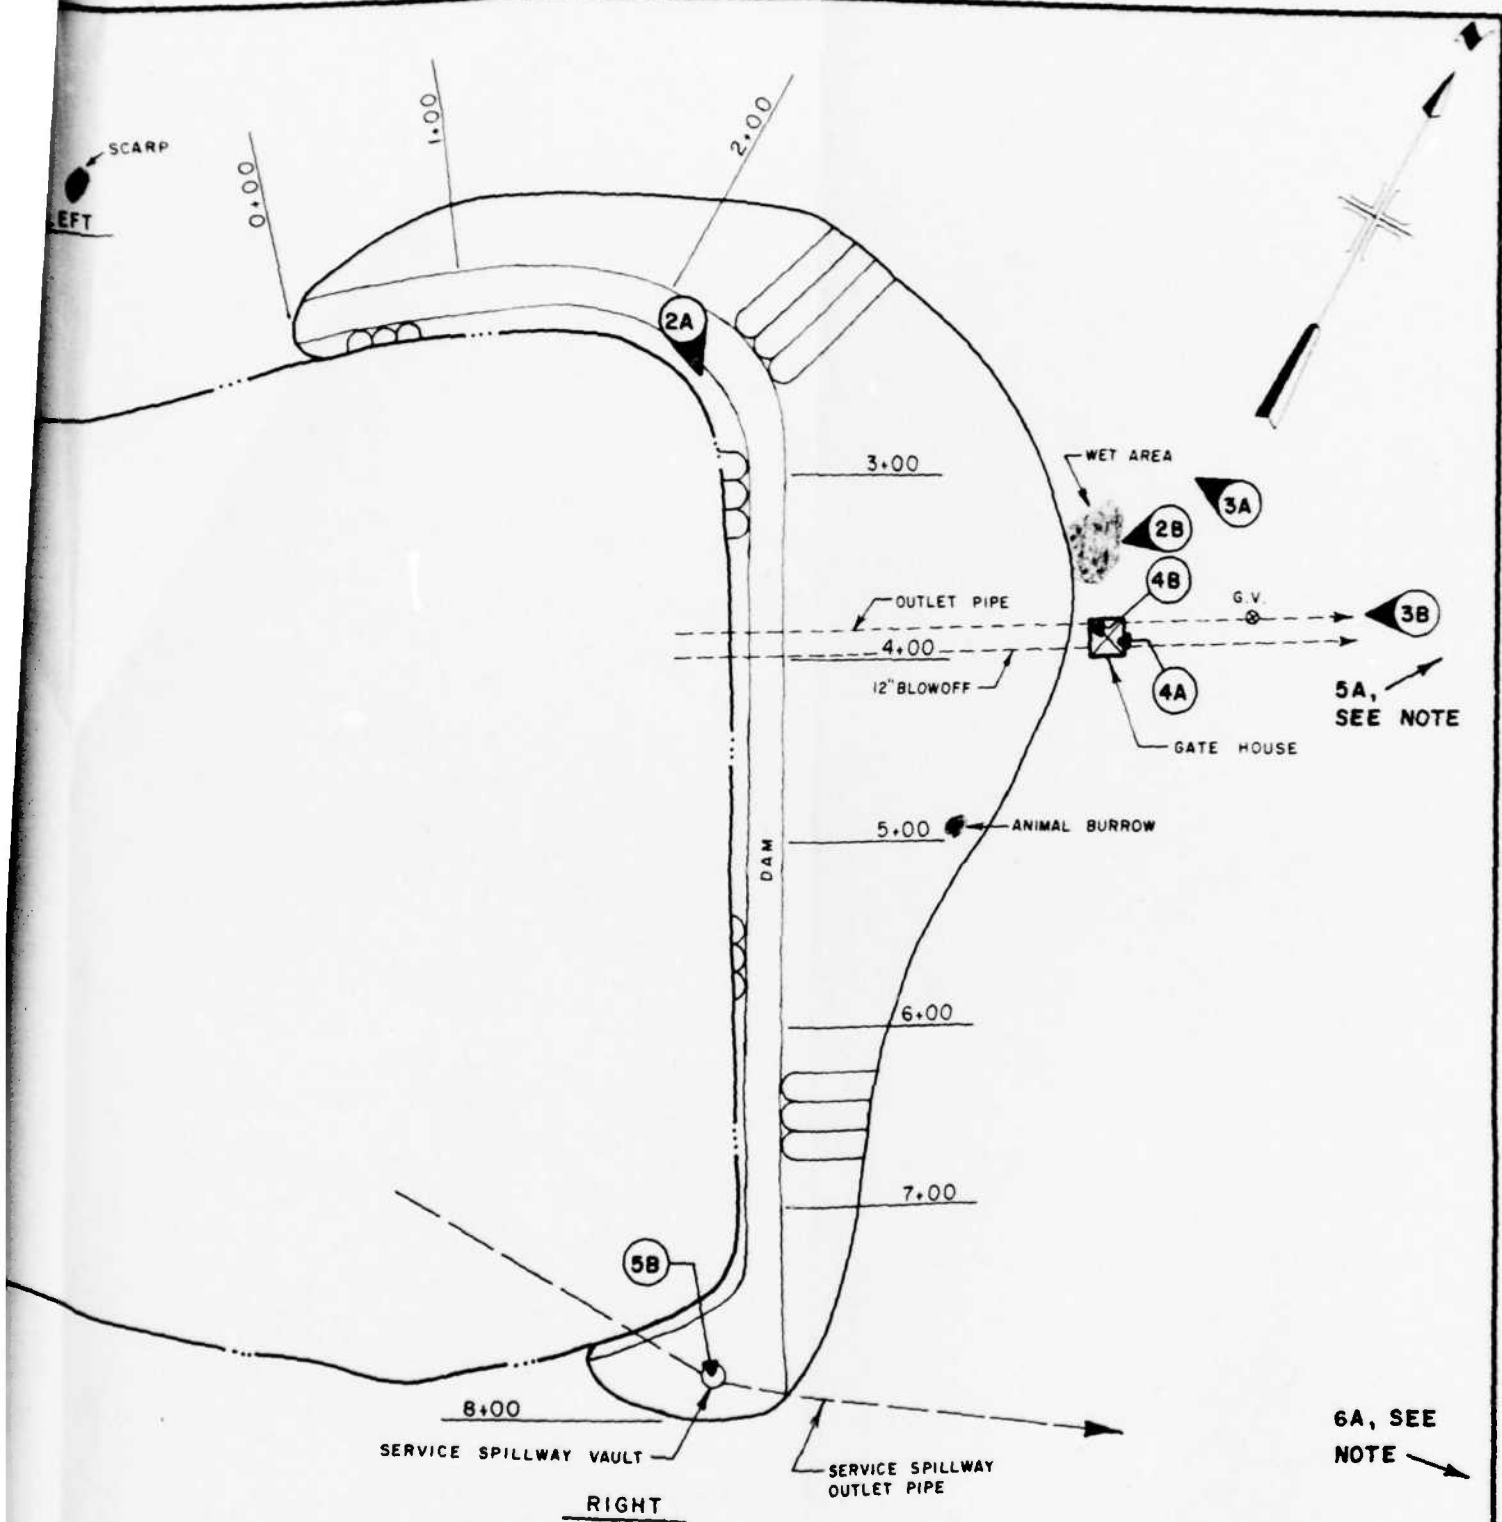
ILION RESERVOIR NO. 2 DAM	
PHOTO INDEX MAP	
TOWN OF GERMAN FLATTS	HERKIMER CO., N.Y.
SCALE: NONE	DATE JULY 1981
  <b>C. T. MALE ASSOCIATES, P. C.</b> 1000 TROY ROAD, SCHENECTADY, N. Y. 12309 <small>PROFESSIONAL ENGINEERS LAND SURVEYORS LAND PLANNING CONSULTANTS</small>

PHOTOS NOT LOCATED

PHOTO 5A IS AT D/S END OF BLOWOFF

PHOTO 6A IS AT D/S END OF SERVICE SPILLWAY OUTLET PIPE
